INVESTIGATION OF CONSTRUCTION FAILURE OF REINFORCED CONCRETE COOLING TOWER AT WILLOW ISLAND, WEST VIRGINIA

Center for Building Technology
National Engineering Laboratory
National Bureau of Standards
Washington, D.C. 20234

November 1979

Sponsored by
Occupational Safety and Health Administration
U.S. Department of Labor
Washington, D.C. 20001

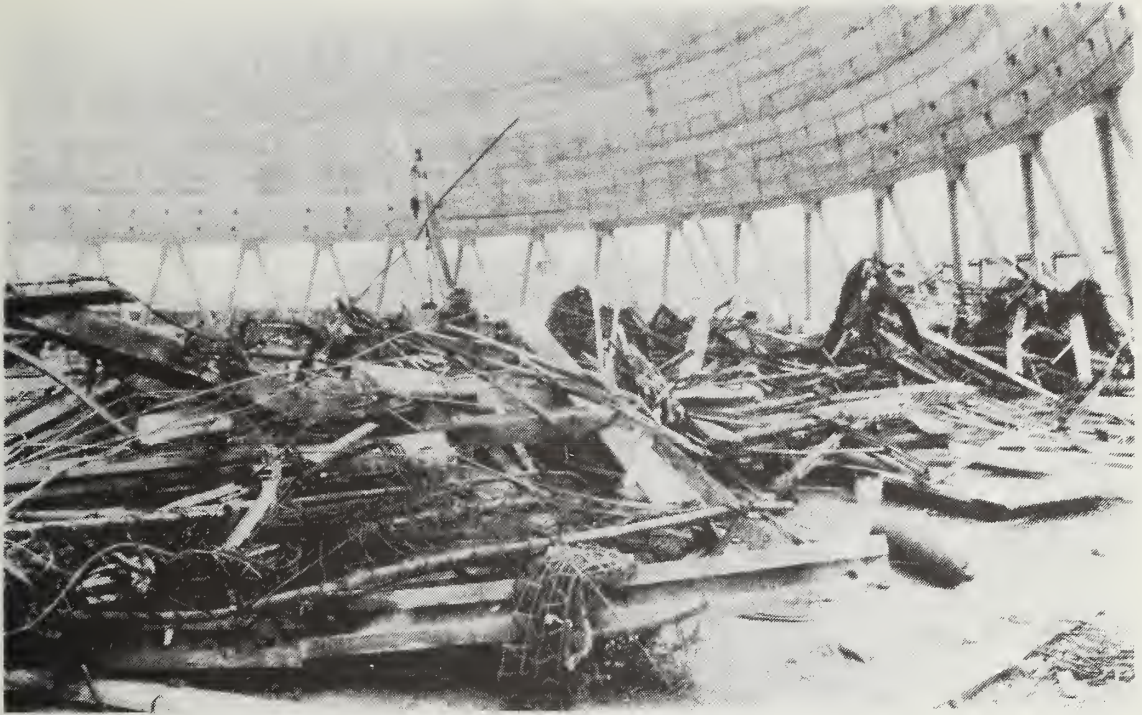
Figure 3.2 Top of Lift 27 Showing Jagged Edge

As can be seen in figures 3.2 and 3.5, vertical bars at the top of lift 27 were bent toward the inside of the tower. None of the vertical bars examined at locations around the top perimeter of the tower showed any signs of fracture.

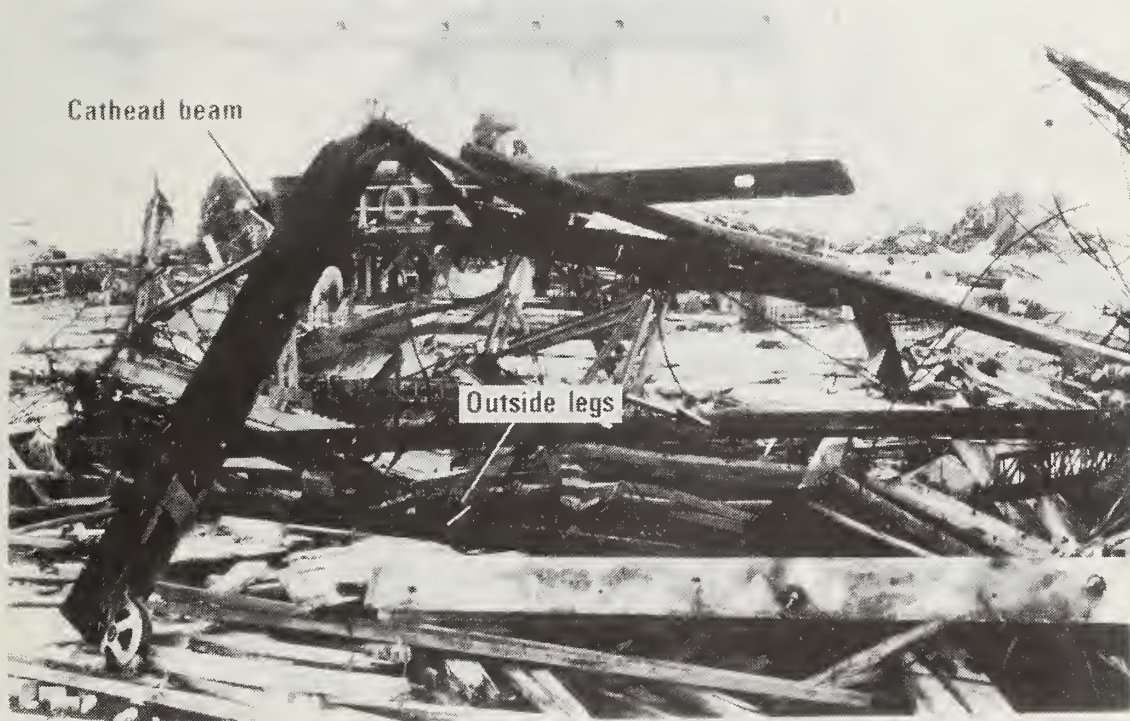
Figure 3.15 Inside Legs of Cathead Gantry No. 4

Figures 3.15 and 3.16 show the inside and outside legs of cathead no. 4. All four legs remained straight and showed no sign of damage. As is seen in figure 3.16 the cathead beam was severely bent. However, close examination showed no sign of buckling of the beam. It was concluded from this observation that the beam was bent after the collapse had initiated.

Figures 3.15 and 3.16 show the inside and outside cathead legs, respectively. As discussed in section 3.2, examination of all four individual legs showed no signs of damage or buckling. Support brackets for attachment of the legs to jacking frames were still intact. No welding failure of the square tubular legs to the supporting bracket was noted.
